CIVIL AVIATION SAFETY AUTHORITY OF PAPUA NEW GUINEA

SAFETY ALERT BULLETIN (SAB)

SAB NO: 01/2023

TITLE: HIGH RISK OF SEPARATION OF MAINWHEELS FROM AIRCRAFT DUE TO FAILURE OF MAINWHEEL ASSEMBLY BEARINGS

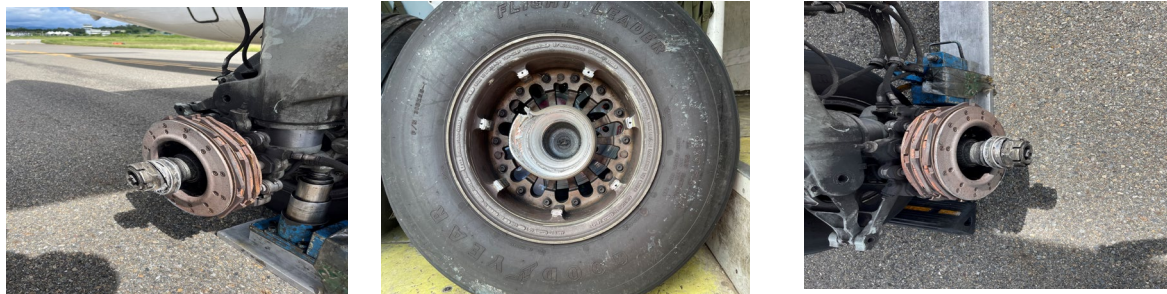
Inspection by CASA PNG of the detached wheel and bearing debris, found that the wheel nut was still in position on the axle with its locking devices correctly installed (see figure 1)

Figure 1- RH outboard Mainwheel detaches from P2-ANO aircraft on landing roll.

- (I) Scrap/Replace main wheel bearings at every tyre change or propose other fixed operating life based on air operators component reliability data, acceptable to the Director; and
- (II) Submit the necessary aircraft maintenance program (AMP) amendment applications to CASA for review and approval of change from 'on-condition' to a fixed 'operating/scrap life' for all main wheel bearings.

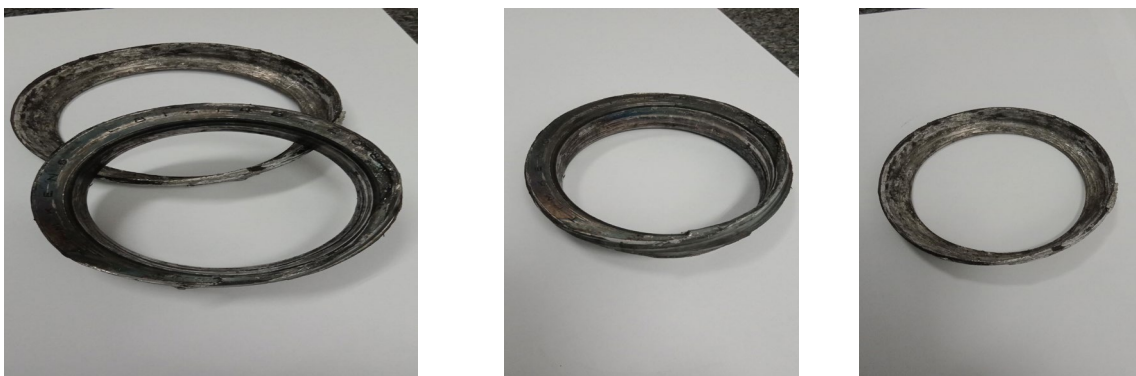
1. Loose or worn cage bearing returned to service
2. Heavy/Hard landings inducing radial shock loads and bearing cage wear
3. Grease contamination – loss of bearing grease causing cage wear
4. Poor wheel installation procedures
5. Excessive wheel shimmy due to worn linkages
6. Brake judder or vibration causing cage wear

Figure 5 shows the damaged mainwheel bearings and its cup recovered from taxiway 32F Port Moresby.

Figure 5 – damaged mainwheel bearings and its cup
